# NASA SGSLR Power and Lightning Protection System

**Abstract:** The Space Geodesy Satellite Laser Ranging (SGSLR) Lightning Protection System will use a multi-tiered system to protect the station's sensitive electronic equipment and instrumentation. Without such protection, a ranging system can incur extensive electronic equipment damage and/or lengthy operational interruptions. As an example, on June 14, 2015, severe lightning occurred at the Goddard Space Flight Center (GSFC), location of the SGSLR Prototype, the Next Generation Satellite Laser Ranging system (NGSLR). When attempting to power on the various equipment of the NGSLR the following workday, it was realized that the system suffered significant damage to almost all major subsystems: meteorological, communications, timing, aircraft avoidance, optical bench, computer, security, and Heating Ventilation Air Conditioning (HVAC). The adjacent Mobile Laser Ranging System (MOBLAS) 7 station system incurred damage as well because of common signal paths between the systems. Another example of severe lightning damage occurred this year at the McDonald Laser Ranging System (MLRS) in Fort Davis, Texas, US. As a result of these inc

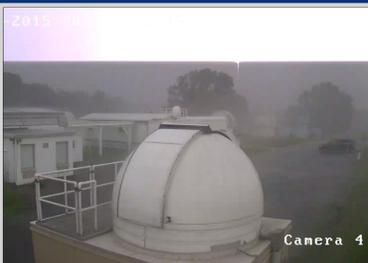
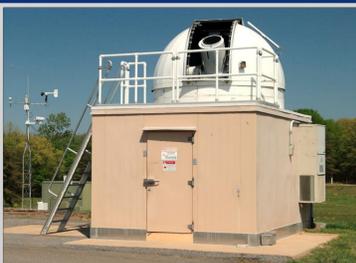
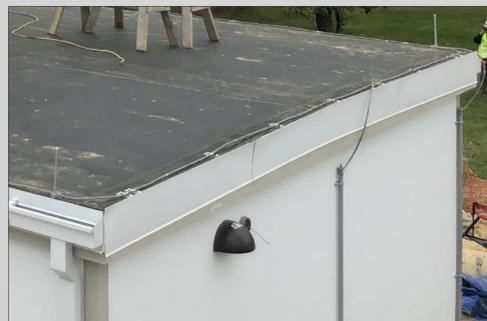
On June 14th, 2015, the NGSLR experienced a lightning strike. Outside security cameras recorded video of the storm as it passed over the system. The storm was short and intense with heavy rain and many lightning strikes. Though the security system was damaged, video was able to be extracted from the DVR. Heavy rains and lightning began at 21:18 local time. At 21:35 local time the NGSLR security cameras stopped functioning; it is believed this is when the damaged occurred. The image to the left is a frame from the security video showing a lightning strike at the GSFC GGAO in the background and the NGSLR in the foreground. Image to the right is of the NGSLR.

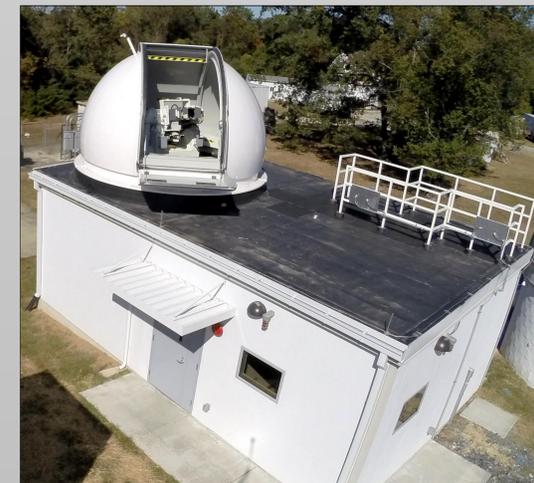
To minimize damage caused by lightning to external data and coms interfaces, SGSLR uses fiber optic transceivers. Data interfaces for the LHRS, Pressure and Temperature and Humidity, sensors, Sky Camera, Anemometer, Horizontal Visibility and Present Weather sensors, GPS antenna and internet/voice comms are all optically coupled between the sensor outside the shelter and equipment inside the shelter.
