## Field maintenance of the SLR telescope at TIGO

### Abstract

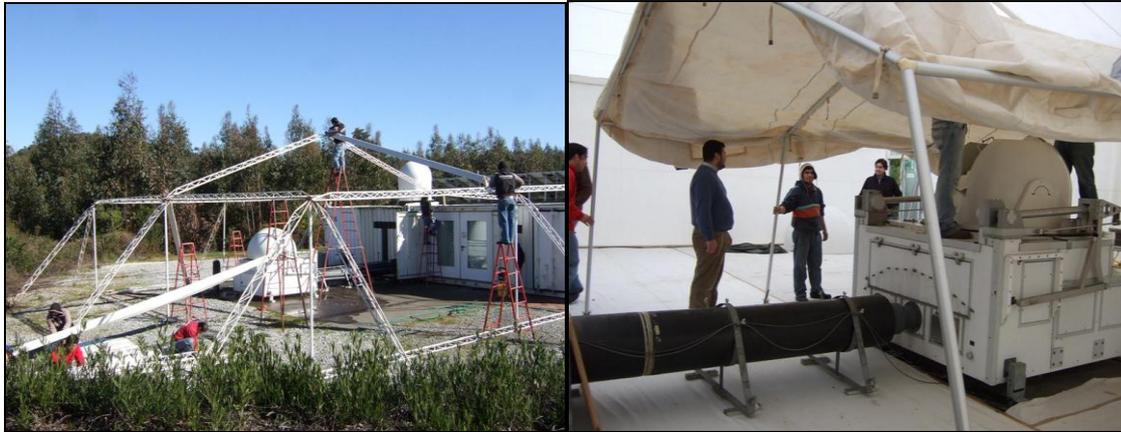
In order to prevent this, we set up a protective construction around the telescope module consisting of two tents, depicted in Fig. 3: First a large stable pavilion tent was erected, which was provided by a catering company. This external tent provided rain and wind

protection during the intensive rain season in Southern Chile on a 12x12 m area around the telescope. The smaller second tent was built inside the external one and enclosed the telescope cart in a 6x6 m area. Inside this internal tent, we installed an air filtering and conditioning system, hourly pumping 3400 m<sup>3</sup> of clean and dry air (> 99 % filtering efficiency for 5 μm particle size and < 20% rel. humidity) from the pre-heated external into the internal structure. By injection through a tube system a constant dry air circulation and overpressure inside the internal tent were obtained, pushing dust particles outside the internal tent. With this setup, “quasi clean room conditions” were established, allowing for the replacement of the optical components in the field.

**Figure 3.** Construction of two interleaved tents to provide clean work conditions.

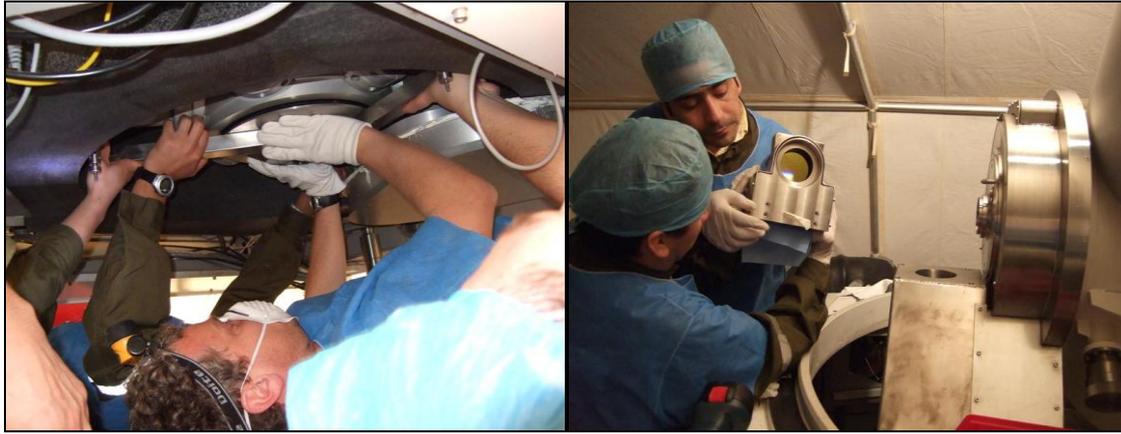
**Figure 4.** Access to the prisms required working underneath the mechanical structure supporting the telescope. Great care was taken to prevent dust from entering the open Coudé path.

The moving part of the telescope, which rotates about the azimuth axis, is mounted on three flat air bearings floating on a monolithic granite bench, indicated by the shaded areas in Fig. 2. In order to access the lowest prism FP7 (reflecting the beam into the azimuth axis) the entire mechanical structure including the granite bench, with a total weight of about 2000 kg, had to be lifted by about 40 cm, which was done by a built-in manually operated mechanism. After disassembling various mechanical parts of the telescope FP7 and the other Coudé prisms were removed together with their mounts. The prisms of size 115 x 98 mm are cemented into their individual mounts by a high-performance flexible epoxy (3M Scotch-Weld 2216B/A). As it is difficult to remove the cemented optics from the mounts without damage, we decided to re-build the four complex and individually different mounts. This work, as well as the installation of the new prisms (manufactured by Laser Components,
